Beyond the Pits: Avoiding Costly Downtime Using Novocoat™ Metal Repair Products

Asphalt Emulsion
Mixing Tank

Challenge: Restoration of metal mixing blades and protection of steel mixing tank interior while achieving minimal downtime and monetary expenditure

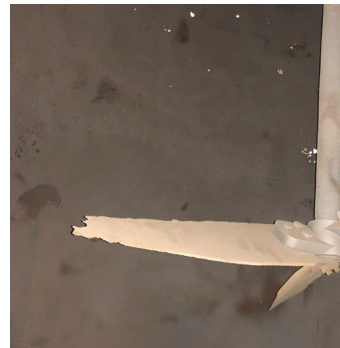
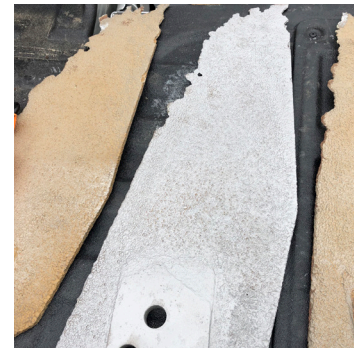
1. Interior of asphalt emulsion tank showing holes from corrosion. Corroded metal mixing blades showing deep pits and missing edges.

Novocoat EP3300 Paste/Caulk was selected to restore the mixing blades and repair damage to the steel structure of the

tank. Novocoat EP3300 is a two-component, 100% solids trowel grade epoxy Novolac paste used as a multipurpose, durable repair composite. It quickly cures at room temperature, with no shrinkage, expansion or distortion, and is fully machinable using standard tools. Being well suited to resurface pitted metal, it proved to be an ideal repair solution in conjunction with expandable metal mesh for the mixing blades. The holes in the tank walls were also repaired using Novocoat EP3300 paste with 1.5 oz chopped strand fiberglass mesh as a reinforcement medium.

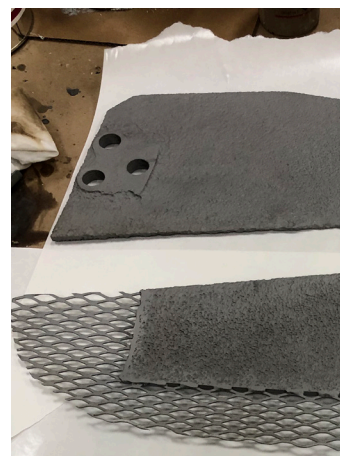
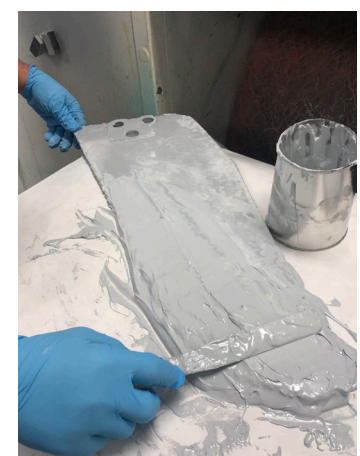
2. Corroded edges of mixing blades being replaced with metal mesh and filled in with Novocoat EP3300 Paste/Caulk.

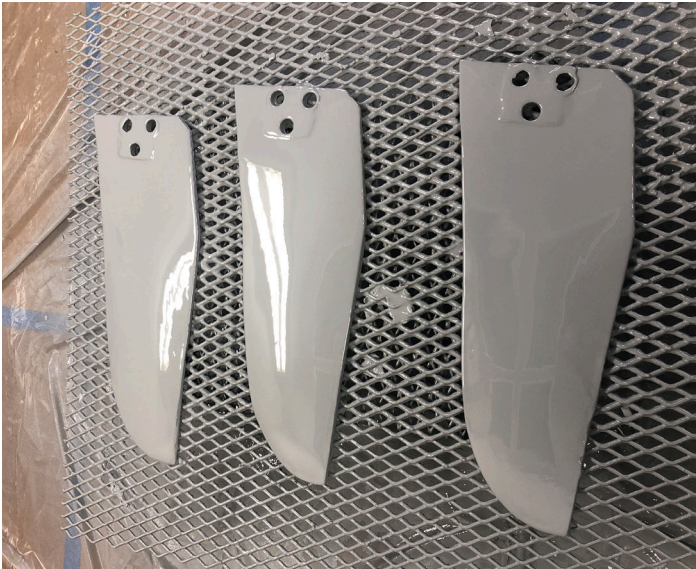
3. Mixing blades coated with Novocoat SC3300 Novolac Epoxy Lining.

Two coats of Novocoat SC3300 Novolac Epoxy Lining were then applied to the blades and the interior of the tank, with a sheet of 1.5 oz chopped strand fiberglass embedded in between coats of the tank lining. Novocoat SC3300 is a solvent free, 100% solids novolac epoxy lining that possesses a low permeation rate, which is ideally suited for internal tank lining due to superior chemical and heat resistance in immersion service.

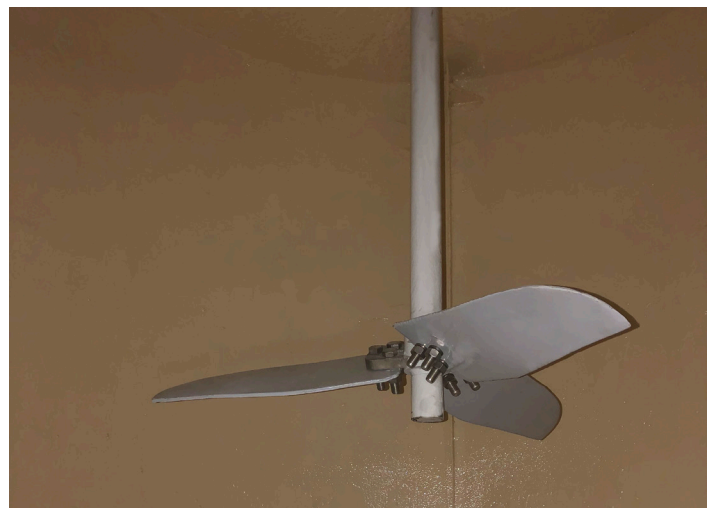
4. Finished interior of mixing tank with restored mixing blades.

The tank became operational approximately one month after completion of the work in August 2019, which was much sooner than replacing the tank altogether, and at a lower cost. Two years after completing the tank refurbishment, the tank was reinspected and observed to be mixing asphalt materials flawlessly, with initial examinations indicating that the lining looked brand new.
